Penetration of chloride from de-icing salt into concrete from a 30 year old bridge

Rob B. Polder and Angelica Hug
TNO Building and Construction Research, Rijswijk, The Netherlands

This paper presents the analysis of chloride profiles obtained from a reinforced concrete bridge. It was the bicycle part of the Berkumer bridge near Zwolle, The Netherlands. For about 30 years, this bridge was exposed to de-icing salts. The bicycle lane was coated with an epoxy coating. The parapets (side walks) were left uncoated. A total number of 36 chloride profiles were analysed using a diffusion model. The chloride diffusion coefficient is typical for Portland cement concrete in wet conditions, about $3*10^{-12}$ m²/s.

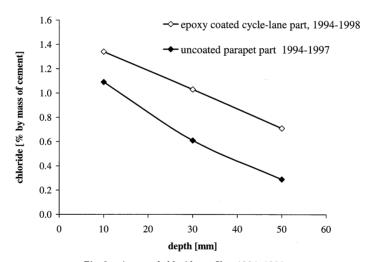
Fig. 3. Averaged chloride profiles, 1994–1998.

Figure 3 shows chloride profiles obtained from the epoxy coated cycle-lane part and from the non-coated parapet part of the bridge.

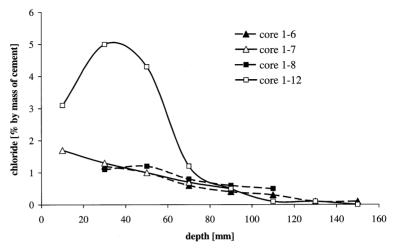
Fig. 4. Chloride profiles from the epoxy coated cycle-lane part of the bridge, data measured in 1994, core samples.

Figure 4 shows chloride profiles from different core samples, taken from the epoxy coated cyclelane part of the bridge. The data were measured in 1994. It is clear that cores 1–6, 1–7 and 1–8 have similar chloride profiles. On the other hand core 1-12 has a much higher chloride contents between 20 and 60 mm depth.

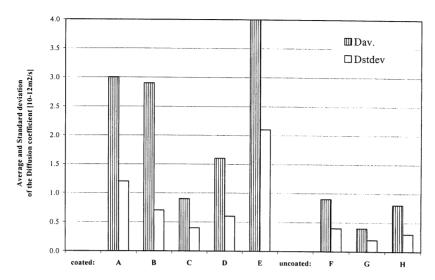
Fig. 5. Average and standard deviation of the apparent Chloride Diffusion Coefficient for the epoxy coated cycle-lane part and the non-coated parapet part of the bridge.

Tables 5.1 and 5.2 give an overview of all diffusion results for cycle-lane and parapets part, respectively. Figure 5 shows the diffusion coefficients (coated and non-coated parts). Figure 6 shows the chloride surface contents (coated and non-coated parts).

The results show a strong variation of apparent diffusion coefficients and surface contents, with both low and high values for $D_{\rm cl}$ and $C_{\rm s}$. However further consideration can help to get a more clear picture.

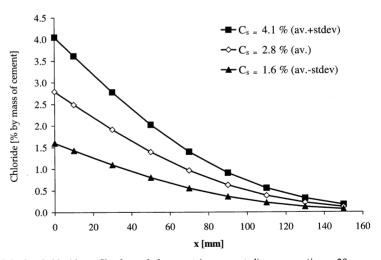
Fig. 8. Calculated chloride profiles for cycle-lane part (epoxy coated), exposure time = 29 year, $D = 3 * 10^{-12} \text{ m}^2/\text{s}$.

For a typical cover depth of 30 mm (upper side of the deck), the chloride content would be about 2% after 29 years (Figure 7), or between 1% and 3% (figure 8). Given the concrete composition, these chloride contents most likely would initiate corrosion.

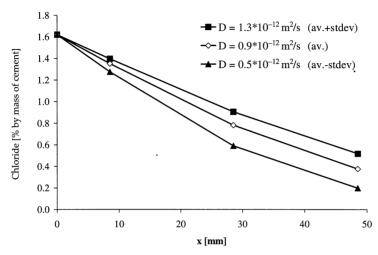
Fig. 9. Calculated chloride profiles for parapet part (uncoated), exposure time = 29 year, $C_s = 1.6 \%$.

A similar approach shows a relatively mild chloride profile in the parapets. Calculated chloride profiles after 29 years are shown in Figures 9 and 10 for the average and extreme diffusion coefficients and surface contents. Generally after 29 years the chloride content at rebar depth (30 mm) is 0.6-0.8%. If we extrapolate to longer service lives, the calculations show that on the parapet, even the worst case ($D_{\rm cl}=1.3*10^{-12}~{\rm m}^2/{\rm s}$, $C_{\rm s}=1.6$ %) probably will not cause corrosion initiation before an age of about 50 years.
