# A closer look at salt loaded microstructures

M.R. de Rooij and C.J.W.P. Groot

Delft University of Technology, Delft, The Netherlands

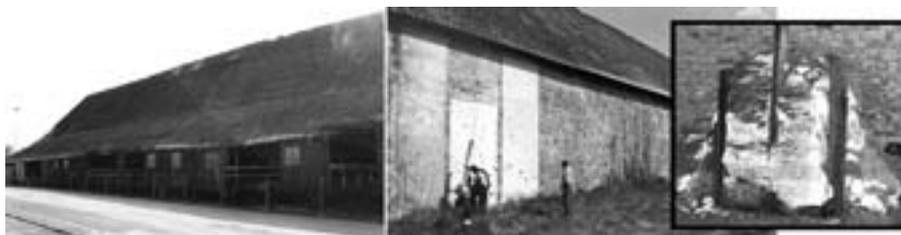
Figure 1: Test site of LRMH at Dieuze. Left: platform for salt transfer, East side; middle: test wall with renders, West side; right storage of salt against wall, inside.

One sample was a non-deteriorated render, the other was deteriorated. The deteriorated sample showed a crack parallel to the surface at a depth of about 7 mm. According to the case study assessment performed by LRMH, the render suffers from cracking due to initial shrinkage and slight granular disintegration. No analysis has been performed to determine the type of salt present, but since the storage facility is for halite, it is assumed that this is the major salt present.

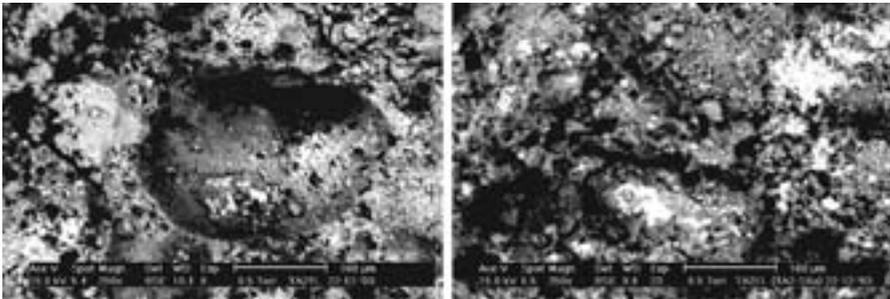
Results by ESEM indicate that in the non-deteriorated sample hardly any salt is visible. In the deteriorated sample, the presence of salt increases with depth (Figure 2). It is noted that the salt is seen crystallized in relatively small crystals; the crystals are not really filling pores but seem to be stuck to solid render matrix.

Figure 2: Increase in salt content going deeper into the render of the deteriorated sample. 10 mm depth (left), 15 mm depth (right).

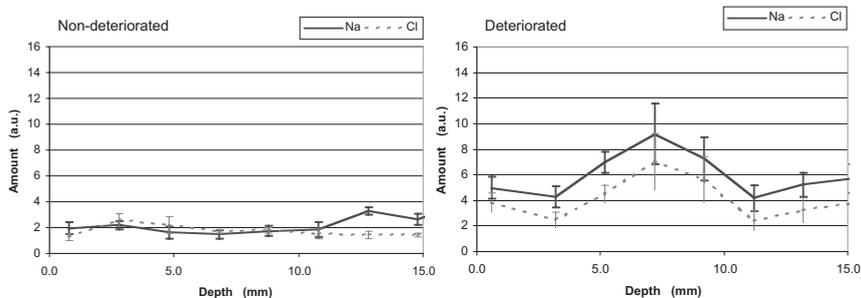
The profile shown in figure 3 does only show Na and Cl levels present in the sample. It is assumed that it represents a halite profile when the Na and Cl levels behave similarly. When the two elements do not behave similar, it must be concluded that other phases play a role. In the profile of the non-deteriorated sample, it can be seen that hardly any halite is present. This does agree with the absence of any damage. The deteriorated sample shows higher levels of salt. The peak in the profile at about 7 mm depth corresponds well with the position of the crack observed macroscopically.

Figure 3: Salt profiles as found in Terrassane render. Left non-deteriorated sample; right deteriorated sample. Error bars indicate variation based on five parallel line measurements.

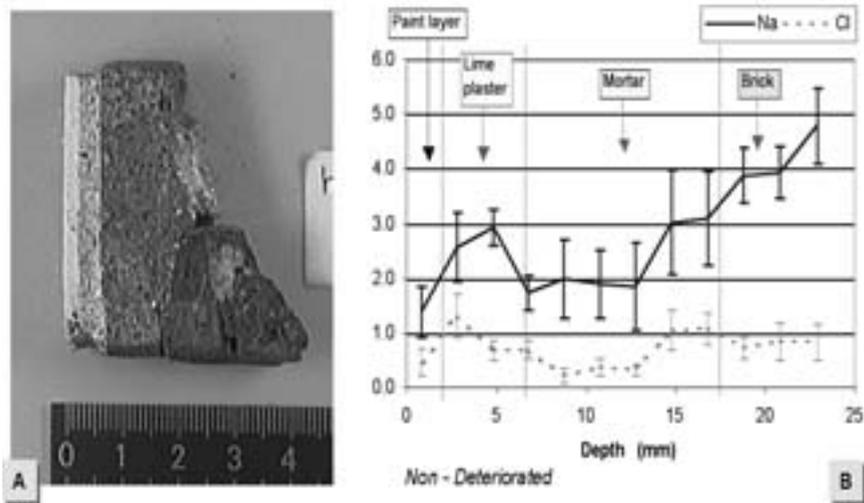
Another field investigation discussed here has been performed by TNO: the Engelmundus church, situated in Velsen, the Netherlands. The plaster is in the interior of the church and suffers from peeling of the paint layer, sanding, scaling and crumbling of the plaster. The discussion in the remaining part of this section focuses on a non-deteriorated sample, which is shown in figure 4a. This sample is interesting because of its multi-layer nature.

In figure 4b, the EDX profile is given for the elements sodium and chloride. Actually, it is not known what kind of salt is present in this sample. Considering the profiles of both sodium and chloride, the presence of halite may be assumed. This is based on the relative similar behaviour of the levels of sodium and chloride. Further analysis of the EDX sodium profile appears to reveal that the salt content is related to the microstructure of the layers, see e.g. the change in salt content going from mortar to the plaster layer. The change in microstructure from the fired clay brick to the plaster corresponds to a sharp difference in the relative concentration of salt across the interfaces between both microstructurally different materials.

Of course, it should be realized that the analyses are based on the assumption of the presence of halite. In reality, this does not need to be the case. In the profiles, this would emerge from a deviation in the similar trend between sodium levels and chloride levels. An example of this effect is shown in the brick part of the sample. Here, sodium keeps increasing at larger depth of the sample while the chloride level remains the same. This indicates other salts being present or difference in composition of the brick itself.

Figure 4: Cross-section of a non-deteriorated sample from Engelmundus church (a), with corresponding sodium and chloride profiles through the various layers (b).

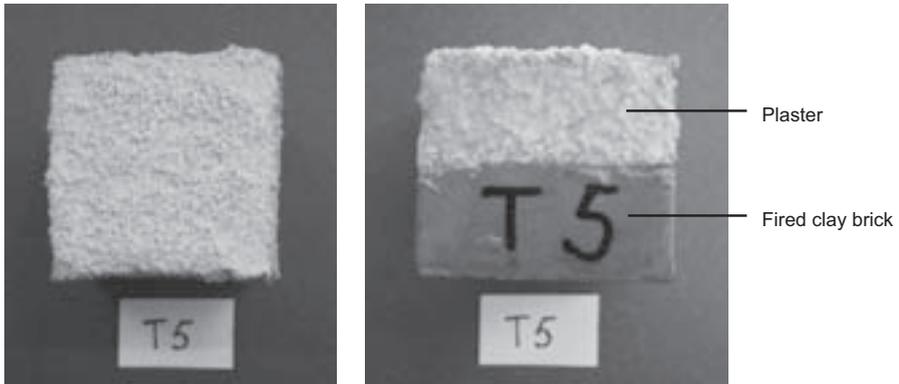
A typical result as it is documented from the COMPASS-TEST is given in figure 10. Here a plaster is shown on top of the fired clay brick substrate at the end of the test, after five cycles of contamination. Sodium chloride has been transported through the plaster, in this case the homemade TNO plaster, and efflorescence is shown at the outer surface/top side of the plaster. No cracks are visible in the sample.

Figure 10: Final result after COMPASS-TEST for home made TNO plaster. View of topside (left), view of side (right).

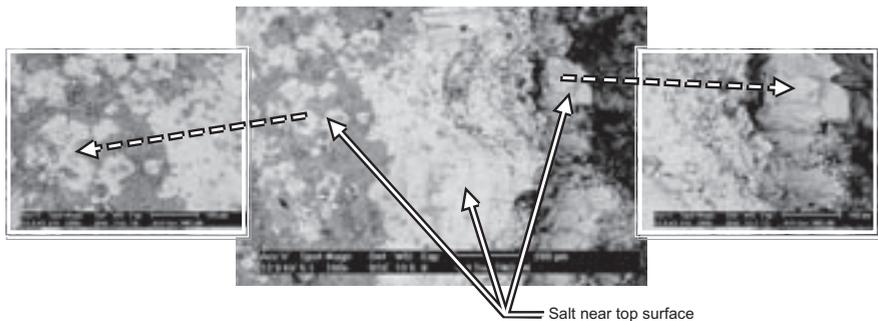
Figure 11: Halite efflorescence on the home made TNO plaster as seen by electron microscopy, showing at least three different crystal habits of the salt.

Besides this macroscopic observation, the microstructure and efflorescence can also be studied at a microscopic level. Observing the same halite efflorescence using a Philips XL30 ESEM, the salt efflorescence then appears as shown in figure 11. The salt is present as patches, which form a continuous layer at the surface, while the most outer salt crystals on the topside of the plaster/salt crust are oriented like small standing crystal columns. Hence, within a short distance (less than 1 mm), the morphology and distribution of the halite efflorescence shows at least three different habits (see centre image of figure 11).

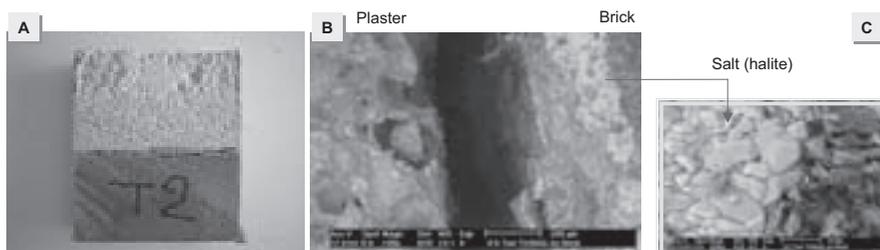
Besides efflorescence, cracks are also observed regularly in the COMPASS-TEST. A typical example is shown in figure 12a: a crack at the interface plaster/substrate. In this case, no efflorescence is visible on the outer surface of the plaster. The plaster shown here is the trass lime Tubag plaster with a mass water repellent. Observation by ESEM shows the internal story. The salt (halite) can be observed in a small band just below the interface plaster/brick (see figure 12 b and c) Beyond this band of salt, more towards the top surface of the plaster, salt

cannot be detected anymore, as has been confirmed by EDX analysis. In this case the mass water repellent is completely blocking the transport of salt through the plaster.

Figure 12: Final result after COMPASS-TEST for a trass lime Tubag plaster with a mass water repellent. Macroscopic view (a). ESEM observations: plaster/brick interface (b), detail of salt crystals (c).

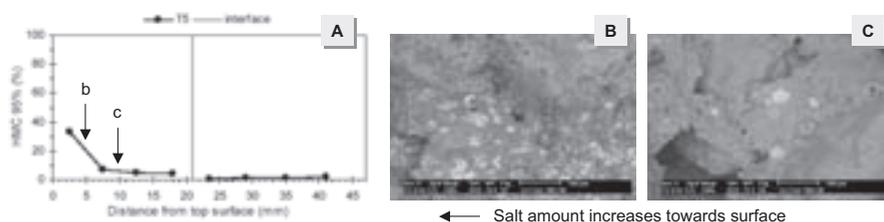
At the end of the COMPASS-TEST, a salt profile through the plaster-brick system can be obtained through the use of hygroscopic moisture content (HMC) measurements. Such a salt distribution graph is shown in figure 13a for the home made TNO plaster. The patches of halite salt that were already shown in figure 11, increased in number per ESEM image when scans were made going from the middle of the plaster towards the top surface of the plaster, see figure 11 b and c. This increase in salt content was also confirmed by EDX analysis.

Figure 13: Distribution of salt (halite) over the plaster thickness as determined by HMC (a) and observations by ESEM (b and c). The locations of ESEM images are indicated in the HMC graph.
