Roof failures due to ponding – a symptom of underestimated development

J.N.J.A. Vambersky

Delft University of Technology and Corsmit Consulting Engineers, Rijswijk (ZH)

Key words: Light-weight flat roof, rainwater ponding, structural failures, structural safety

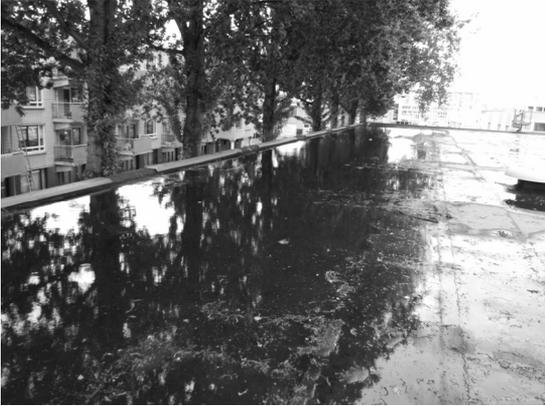
Figure 2: Rainwater ponding, no emergency overflow in the roof up stands

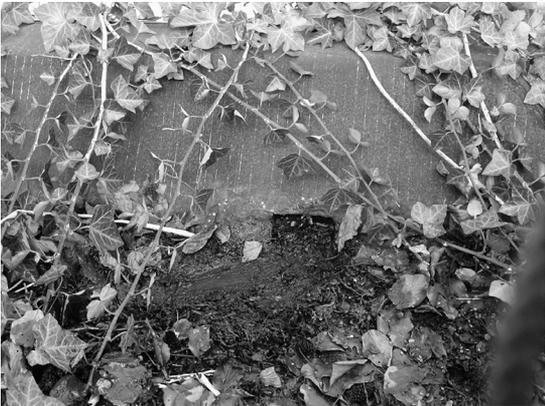
Figure 3: Plant growth and fallen leaves on the roof

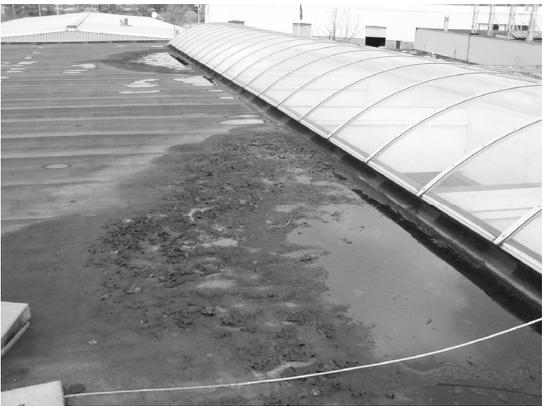
Figure 4: Light street blocking the roof slope results in ponding
