# Salt decay of Morley limestone

Timo G. Nijland

Rob P.J. van Hees

*Key words: Morley limestone, salt weathering, Pieterskerk, Leiden*

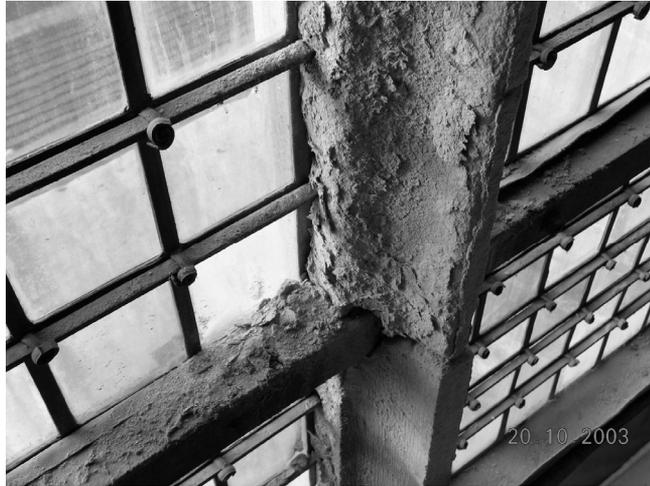
After 80 – 100 years, severe damage was observed on montants in the southwestern and notably northwestern façades of the transept of St. Peter's Church. Contrary to what might be expected, most damage was present on the interior sides of the montants. Damage consisted of severe scaling, flaking and powdering of the limestone (Fig. 1), some of those showing white efflorescence. Remarkably, some montants directly adjacent to each other show severe damage, whereas others do not.

*Figure. 1: Example of severe scaling, flaking and powdering of Morley limestone, west façade of the south transept (situation 2003, prior to restoration).*

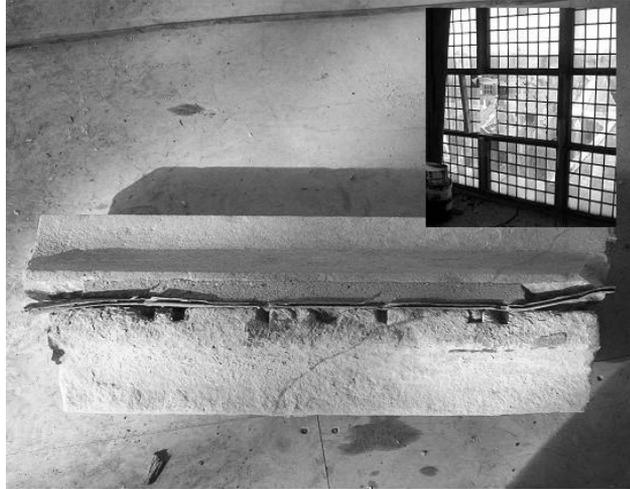
Figure 2: Mantant of Morley limestone removed from St. Peter's Church for laboratory investigation, with the interior side suffering salt damage at the bottom. Inset shows the original position of the mantant.

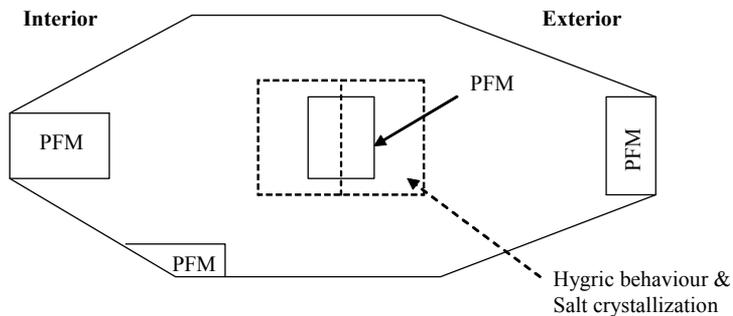
Figure 3: Schematic cross section through the mantant in figure 2, showing the location of thin sections (PFM) and samples for determining hygic behaviour and salt crystallization tests. Samples come from the same cross section.

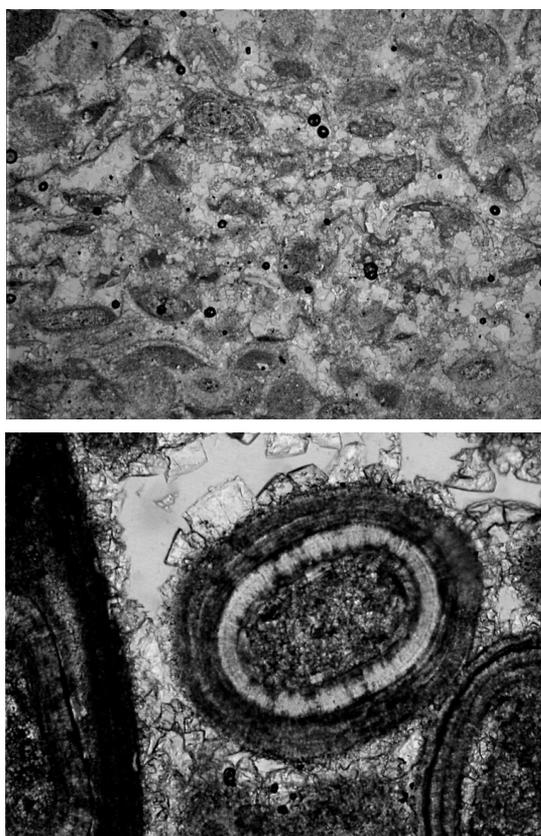
The Morley is an oolitic limestone, with minor bioclasts, and a macroporosity estimated at 20 vol.% (Fig. 4). Ooliths and bioclasts are cemented by carbonate mud partly recrystallized to microspar. The amount of carbonate cement / microspar is about 10 vol.%. Original sedimentary bedding is well developed (Fig. 5). In the mantant showing damage, the bedding is oriented perpendicular to the façade (i.e. parallel to the section in

*Figure 4: Microphotographs showing an overview of the microstructure in the core of the montant (view 5.4 x 3.5 mm) and detail of ooliths near the interior nose of the montant (view 2.8 x 1.4 mm) in Morley limestone.*

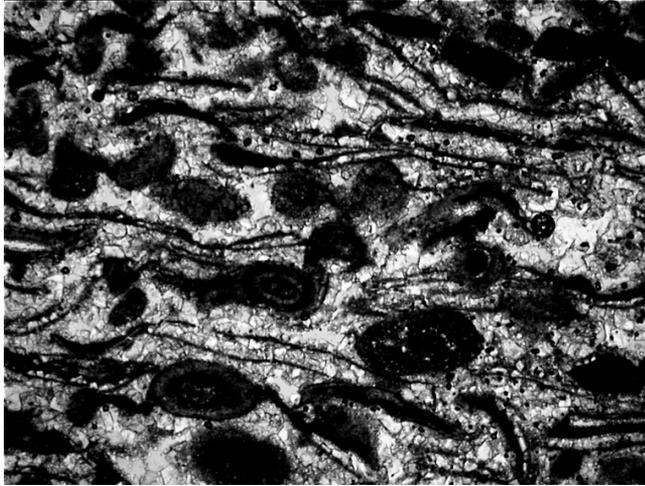
*Figure 5: Microphotograph illustrating sedimentary bedding in damaged Morley limestone (thin section near the interior nose of the montant, view 5.4 x 3.5 mm).*

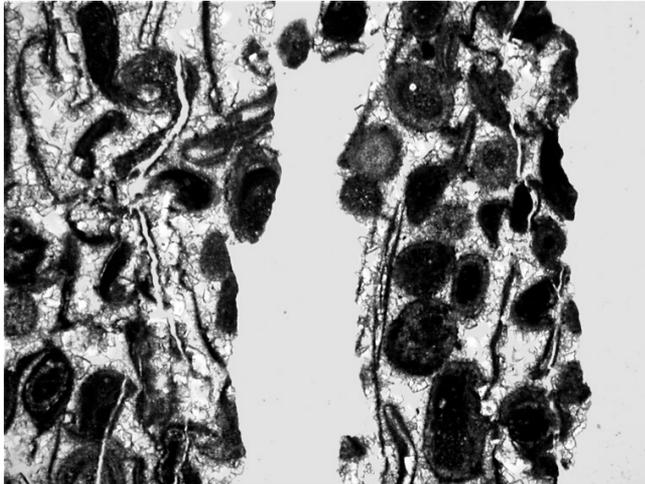
figure 3). In the damaged zones, microcracking and scaling occurs parallel to the original sedimentary bedding, with powdering occurring over the surface (Fig. 6). No formation of gypsum has been observed in thin sections of the montant in figure 2. X-ray diffraction analysis (XRD) of limestone powder sampled from the interior nose of the montant shown in figure 2 indicates only the presence of halite, NaCl. A powder sample from the interior surface of another, less deteriorated montant also shows the presence of a minor amount of gypsum,  $\text{Ca}_2\text{SO}_4 \cdot 2\text{H}_2\text{O}$ . Halite is, however, believed to be the main salt responsible for the observed damage.

*Figure 6: Microphotograph showing microcracking and delamination parallel to the bedding from the lower interior corner of the damaged montant (view 5.4 x 3.5 mm)*

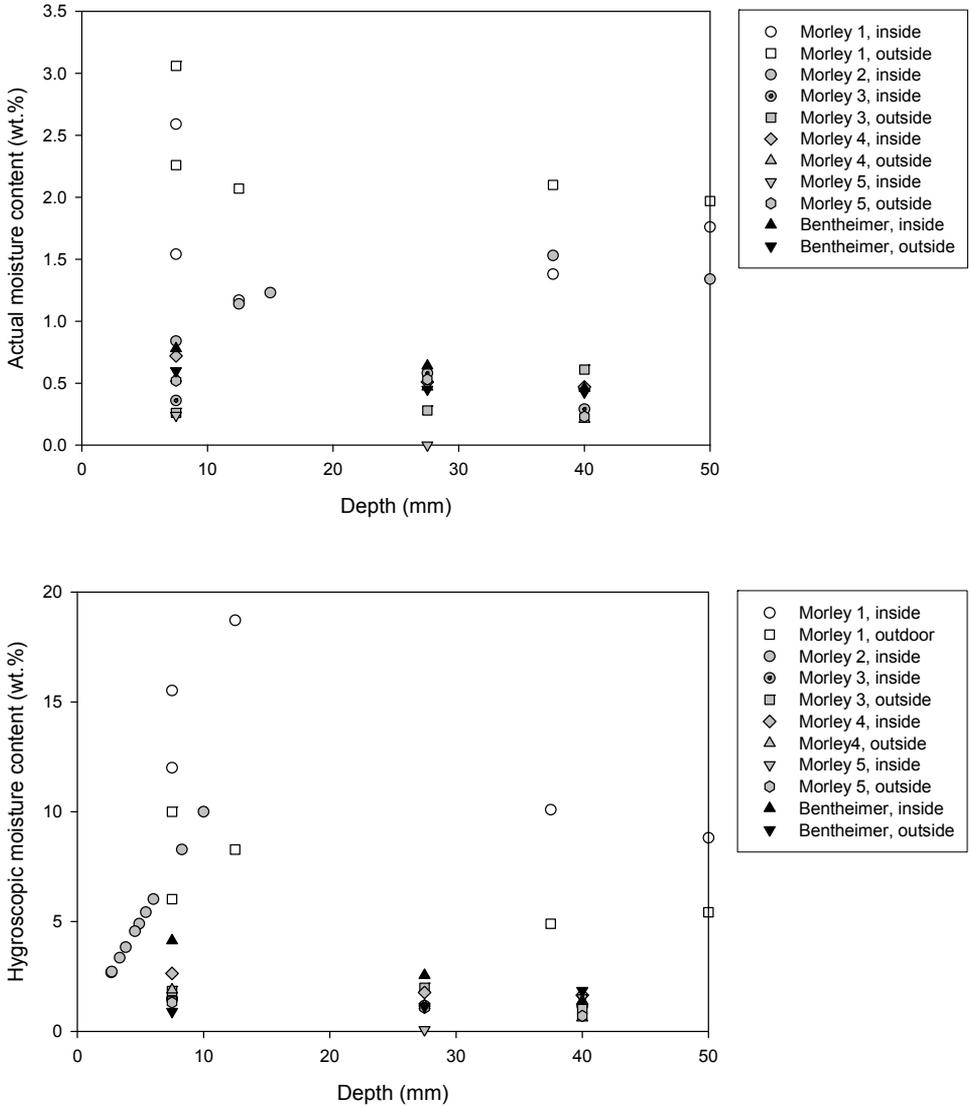
Figure 7: Variation of actual (above) and hygroscopic, at 96% (below) moisture contents with depth for deteriorated Morley limestone (white symbols), not to scarcely deteriorated Morley limestone (grey symbols) and not deteriorated Bentheim sandstone (black symbols).

(hygroscopic) salts present. Results are given in figure 8. These show considerably higher actual and hygroscopic moisture contents for the deteriorated montant compared to both not or amply deteriorated Morley montants. Moisture and (indicative) salt contents in the latter are comparable to that of the montant in Bentheim sandstone. In case of the deteriorated Morley montant, actual moisture contents are lower, hygroscopic moisture

contents are higher in the parts of the montants in the interior of the church than in parts exposed outside.

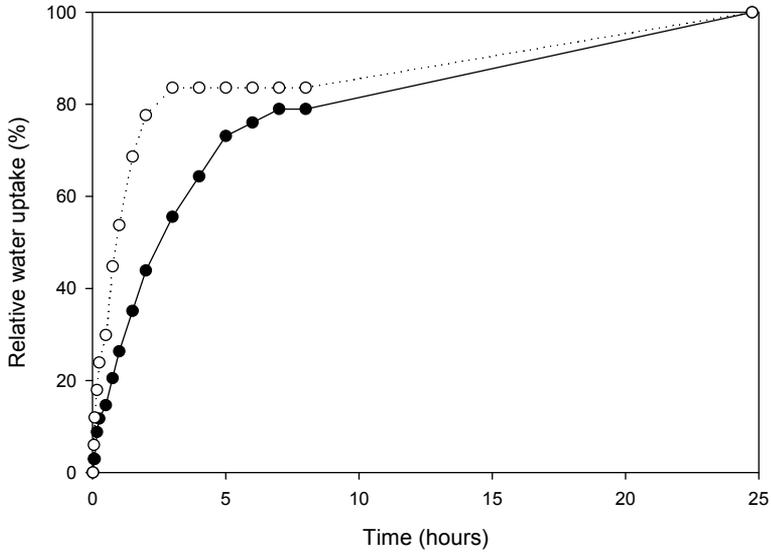
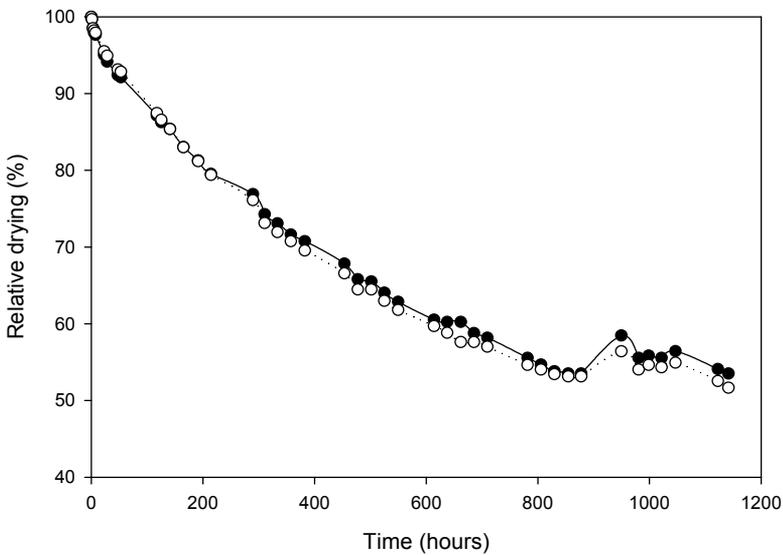
Figure 8: Relative water uptake and drying of Morley limestone (from the interior part of a montant; test in duplo).

Water absorption and drying curves have been determined for two samples cut from the internal part of the deteriorated Morley montant (Fig. 9). Those yield water absorption coefficients of 0.053 and 0.044 kg m<sup>-2</sup> s<sup>-0.5</sup>. On one of the samples, salt efflorescence occurred during drying, apparently from salt already present in the sample. Pore size distributions by MIP have been obtained for both undamaged Morley from the internal part of the montant, and from deteriorated Morley from the interior nose of the montant. Results are given in figure 10. Both show relatively few small pores, -implying relative fast drying-, and a slight shift to larger pores and total porosity with deterioration.

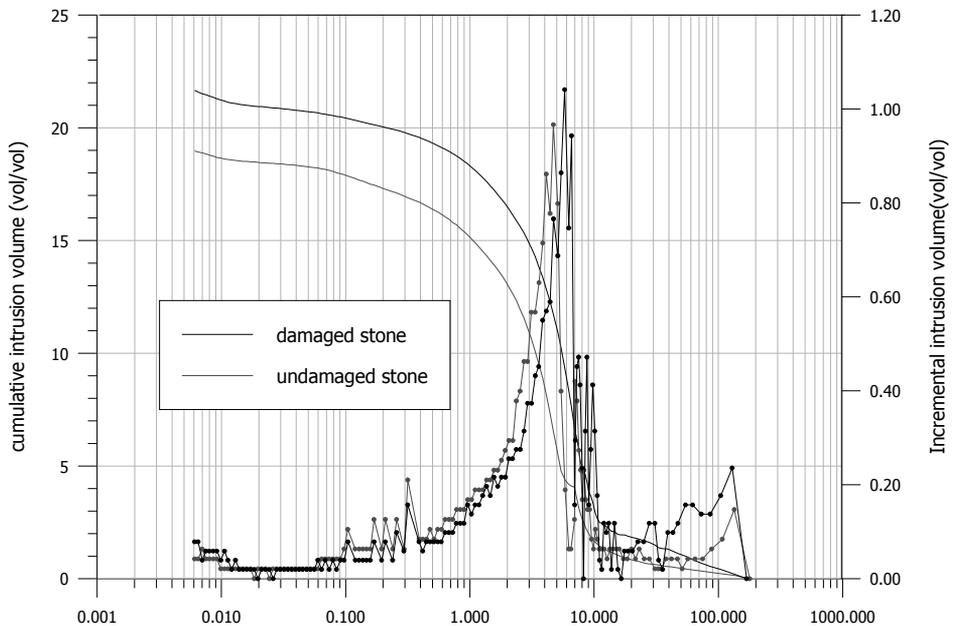
Figure 9: Pore size distributions (diameter in micrometre) for deteriorated and not damaged Morley limestone, as obtained by MIP.
