# **Effects of polypropylene fibres in concrete: Microstructure after fire testing and chloride migration**

J.A. Larbi and R.B. Polder

TNO Built Environment and Geosciences, Delft, The Netherlands

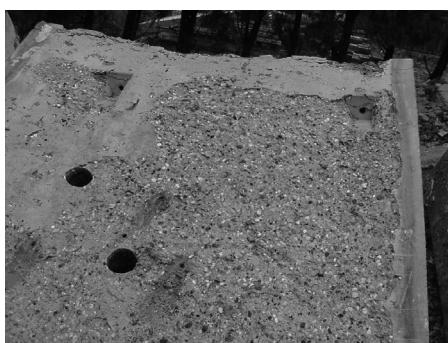
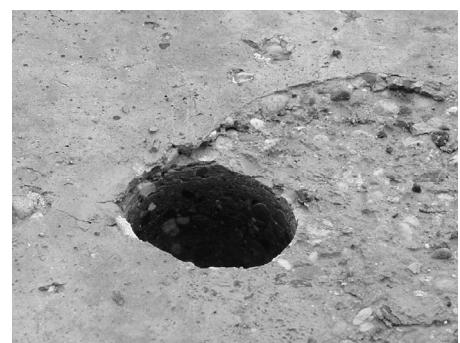
*Figure 1: Portion of one of the tested concrete elements after the fire test showing some of the locations where the cores were removed for further analysis and damage due to spalling*

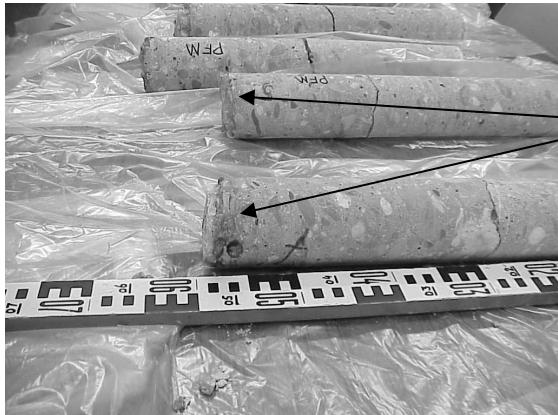
*Figure 2: Overview of some of the cores removed from the two concrete elements for the microscopic studies showing the spalled surfaces and colour changes caused by fire heating*

Directly below the spalled surface, that is, the fire-exposed surface, was a whitish-grey zone, characterised by loss of bonding of the cement paste to the coarse aggregate particles and severe microcracking of the cement paste and the coarse aggregate particles. Around most of the coarse aggregate particles, which consisted essentially of quartzite, chert, sandstone and quartz, most of the cracks were radial, often crossing other cracks from adjacent particles, indicating SiO<sub>2</sub> phase change and reflecting that the zone in question had experienced temperatures exceeding 573°C.

Adjacent to this zone was a thin pink zone, varying in thickness between 0 and 10 mm and showing a less severe form of physical deterioration. This is apparently the zone affected by oxidation of various Fe-hydroxides to hematite, resulting in the pink colour. Beyond this zone, the colour of the concrete, the amount of cracks and the compatibility of the concrete were quite similar to those of the reference, not-heated concrete core. A number of these features are clearly shown on the polished specimens in Figure 3.

Visual examination of samples, often aided with stereomicroscopy, is usually the first step of microscopically diagnosing the extent of damage in concrete cores. This phase of the study is also used to obtain first-hand information about the materials in order to assist in the selection of specimens for further examination by means of PFM. An overview of some of the cores is shown in Figure 2.
