# Repair mortars for historic masonry; Effects of the binder choice on durability

Caspar Groot

Delft University of Technology, the Netherlands (c.j.w.p.groot@tudelft.nl)

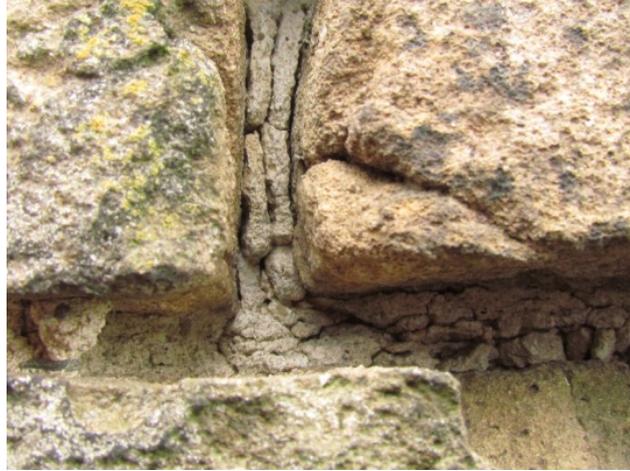
*Figure 3. Frost damage of lime-based bedding mortar caused by a high degree of saturation (in West wall of Ruin De Nijenbeek, the Netherlands)*

Freeze-thaw cycles are in colder parts of the world a major reason for damage in historic masonry (figure 3). Obviously, if a mortar does not contain moisture no freeze-thaw damage is to be expected. Damage only takes place if, as a result of the presence of moisture, a high crystallisation pressure (expansion) can develop, causing higher tensile stresses than the mortar tensile strength. In terms of materials properties this means that for a mortar the degree of saturation, the total pore volume, the pore size and distribution, freezing rate and the mortar tensile strength all contribute to freeze-thaw durability (Hall and Hoff 2002).

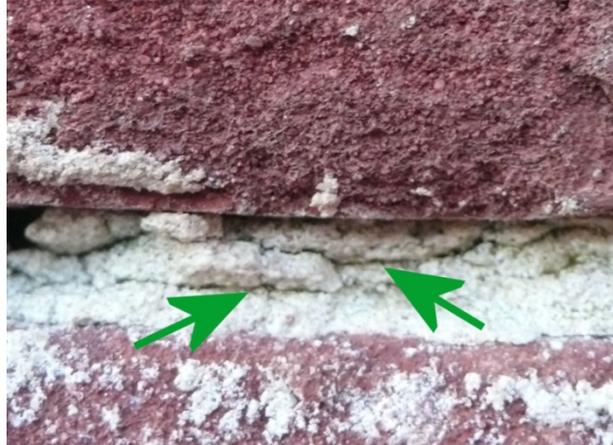
*Figure 4. Frost damage in an uncarbonated air lime mortar due to an application of the mortar too late in the season (Brussels, Belgium)*

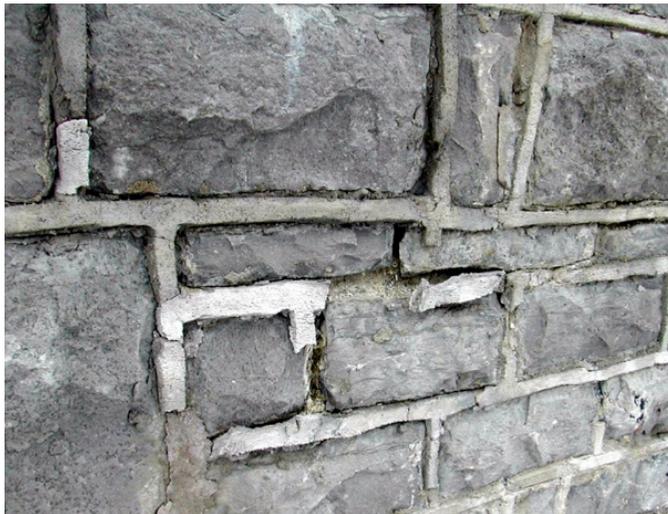
*Figure 5. Push out of a dense repointing mortar caused by frost damage to the bedding mortar. Combination of problems: strong dense mortar (restricts drying, shrinkage cracks allow ingress of moisture); depth of the repointing insufficient (wrong on-site practice). Free-standing garden wall, Ottawa, Canada. (P. Maurenbrecher)*

fill up of the joint. Curing by wetting for a shorter or longer period of time depending on the type of binder used. Practice has learnt that a high percentage of durability problems can be attributed to inadequate on-site practices (figure 5).

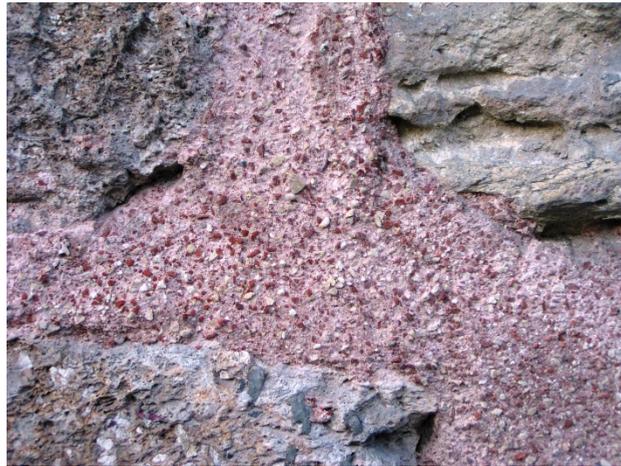
*Figure 6. Mortar containing crushed brick particles as pozzolana (Istanbul)*

Greece), metakaolin (a highly reactive alumina-silicate pozzolan), ashes of some agricultural products, such as rice husk ash, and tuff (consolidated volcanic ash) known as trass (found in Germany). Also crushed bricks and byproducts of industrial processes such as fly ash are used as pozzolans. Basically pozzolanic materials are latent-hydraulic, needing air-lime to form water-insoluble compounds (figure 6).

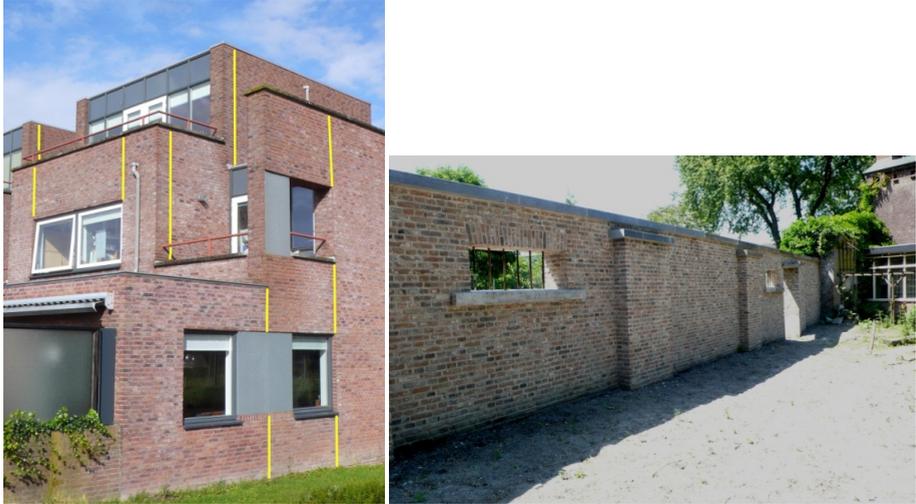
Figure 9. Left: many expansion joints in modern cement mortar masonry (see the yellow lines). Right: in this wall built with a natural hydraulic lime (NHL 3,5) only one expansion joint was applied at the top of the door opening at the rear of the wall.

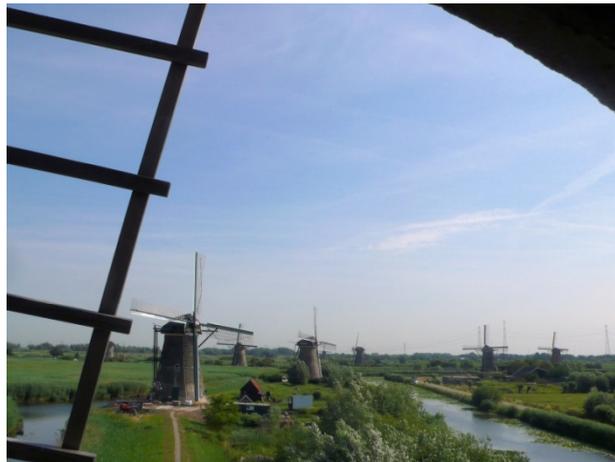
*Figure 12. Water mills built in 1738 at Kinderdijk, the Netherlands. They are almost identical in design, but built by different contractors. Striking are the differences in quality of these mills. From the beginning several of them are suffering from serious rain penetration problems.*

*Others show no problems at all.*

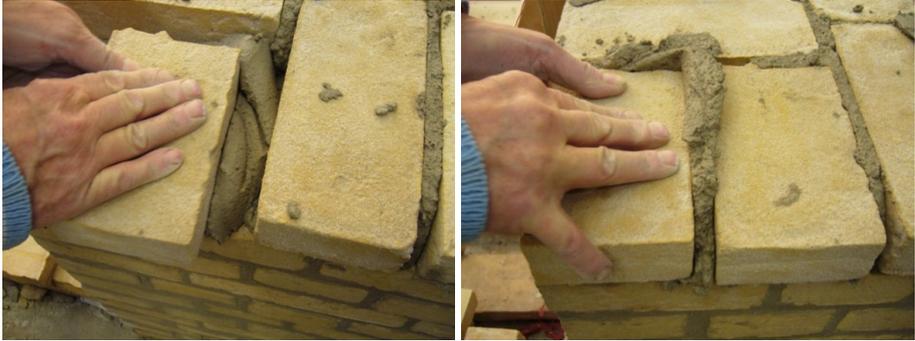
*Figure 13. A basic requirement for water tightness is that during execution no voids are left; to avoid this every brick should be fully surrounded by mortar. This is only possible if the brick laying is done carefully brick-by-brick.*

Proof for this interpretation was found in a field study (Groot and Gunneweg 2005) where examples were analyzed of well-made historic brickwork constructed with high absorption bricks (Initial rate of absorption (IRA)  $> 3 \text{ kg}/(\text{m}^2 \cdot \text{min})$ ) and high porous lime mortars without any leakage problem (the most unfavourable mortar-brick combination with regard to leakage potential). In case of a presence of pores  $> 100 \mu\text{m}$  and cavities originating from wrong brick laying technique, leakage at defined spots may be expected. The reason is that pores coarser than  $100 \mu\text{m}$  contribute to the water permeability through gravity or wind driven water ingress (see Thomson et al. 2004). Hence, leakage may in these cases be attributed to networks of fine cracks, wide cracks throughout the wall, voids in the interior of the masonry (voids, apart from being water reservoirs in the wall, may also promote leaching of soluble material, such as calcium hydroxide). Generally, the porosity of the mortar is finer than of the bricks in low-strength fired clay brick masonry. This means that the mortar may act as a barrier to water transport in masonry. (For more extensive information what may happen as result of moisture transport from mortar to brick see Groot 93 and Brocken 98). Tests with various mortar-brick masonry combinations showed that the barrier effect of air lime mortars is rather low, and the more hydraulic the mortar the higher the barrier effect.
