Laser cleaning of black weathered Obernkirchen sandstone

T.G. Nijland, T.J. Wijffels, C.W. Dubelaar and J.A. Larbi †

TNO Built Environment & Geoscience, Delft/Utrecht, the Netherlands

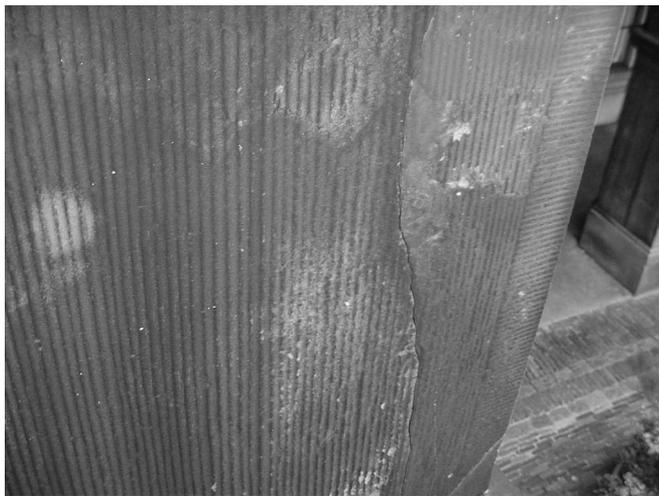
Figure 3: Example of black weathered Obernkirchen sandstone on the façade of the Staten-Generaal, The Hague (january 2003)

The sandstone has been used for many Dutch monuments, such as the town hall of Delft, the Royal Palace in Amsterdam and the Martini tower in Groningen. In the present case, samples have been investigated from the building of the House of Representatives of the Staten-Generaal (the Dutch Parliament), in The Hague. The relevant part of the building was constructed in 1777 - 1793, with the upper part of its façade cladded with Obernkirchen sandstone, the lower part with Belgian blue limestone ('hardsteen'). An example of the black weathering of the Obernkirchen sandstone on the façade is given in figure 3.

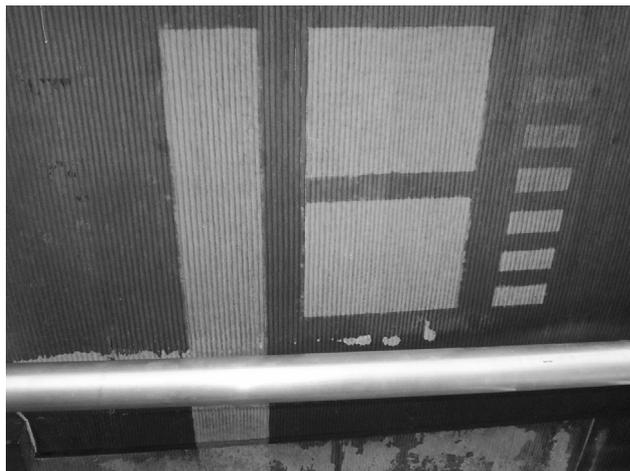
Figure 4: Overview of test panels A. On the right, scale bar made to determine operating conditions of the laser. In the middle, test panels considered to be the right 'end product' by the cleaning company themselves. A detail of these is given in figure 5. For explanation, see text.

Contractor A made a series of test panels both with laser alone and laser combined with dry microblasting. For cleaning, an Nd:YAG laser was used. These are shown in figure 4. To determine operating conditions for this laser, a scale bar (the series of small panels on the right in fig. 4) has been made ranging from almost no cleaning, to cleaning with an intensity that the visual suggestion of damage arises. The scale bar ranges from 700 to 1000, corresponding to an energy density of 0.127 to 0.775 J cm⁻² (Grell 2004). Subsequently, other test panels have been made, of which the middle panel on figure 5 is considered a satisfactory result by the cleaning company themselves (Fig. 5). This was cleaned using a scaling of 900 – 950, corresponding to an energy density 0.517 to 0.608 J cm⁻². Cores from this panel have been obtained for microscopic investigation (Fig. 6). In addition, a core from the scale bar part with maximum intensity (1000) has been collected as reference (sample TNO 00423).

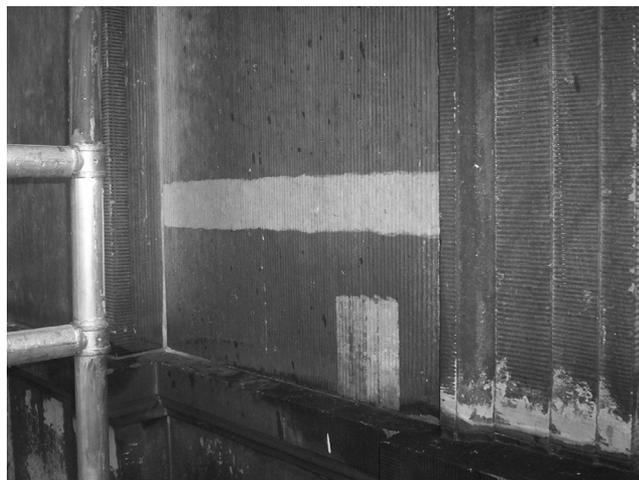
Figure 7: Test panel C cleaned by laser

given in figure 7. These test panels are distinctly more yellow than those made by contractor A. An overview of cores for microscopic investigation is given in figure 9.

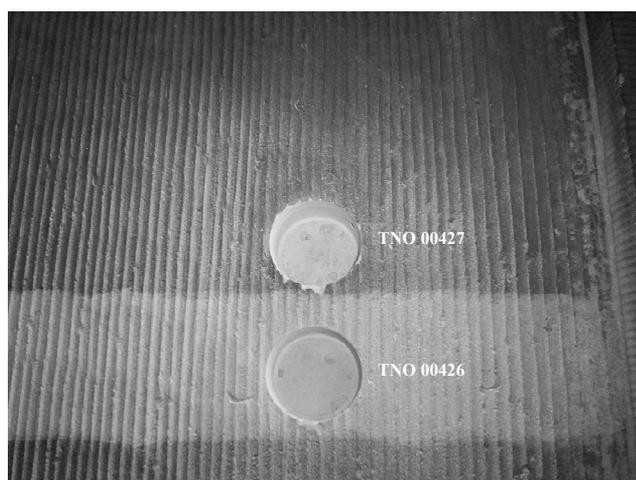
Figure 8: Overview of samples for microscopic evaluation obtained from test panel C
