# Through thickness fatigue strength variation in thick S460 plates

Steel thick plates (i.e. thickness > 80 mm) are increasingly used in wind turbine offshore structures. The fracture toughness of thick plates is well addressed in the literature; however, little is known on their fatigue resistance. Thick plates exhibit distinct features that can present additional structural integrity issues compared to conventional thin steel plates, caused by the significant plane strain effects, heterogeneous through-thickness micro structures and mechanical properties, and inherent larger material defects. This paper presents a comparison between the fatigue resistance of two distinct regions in a 100 mm thick steel slab, namely, the surface region and the core region. High cycle fatigue experimental tests are performed under force-controlled condition for both regions using dog-bone small-scale specimens. Large material defects are observed in the core region. The fatigue results of surface specimen show longer fatigue life compared to core specimens. Large scatter of the data is present in core specimens due to the presence of large voids. The fracture patterns of the different specimens ar

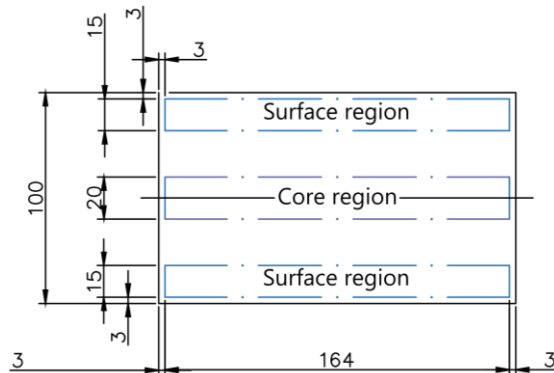
Figure 1. Location of the core and surface regions considered

As the focus of this study is to investigate the fatigue performance of thick plates and identify the difference between the core and the surface region, the specimens were meticulously extracted from these two distinct regions as defined in Figure 1.

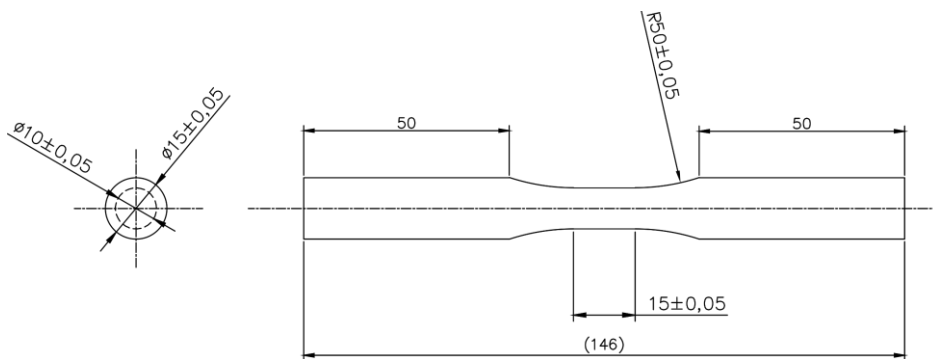
Figure 2. Fatigue specimens geometrical and manufacturing specifications

Figure 2 provides a schematic representation of the fatigue specimens. Core and surface specimens are designated by the letters 'C' and 'S', respectively. The geometry of these specimens meets the requirements ISO-1099 [5]. The specimens design ensures a uniform distribution of stress in the gauge length and minimizes the stress concentration factor (SCF = 1.04) at the radius, as confirmed via the finite element analysis (results not shown for brevity). The specimens were produced perpendicular to the rolling direction. A surface roughness of  $R_a \leq 2 \mu\text{m}$  was achieved in all specimens.

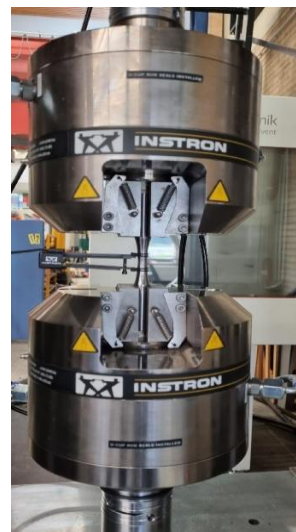
Figure 3. Instron 1251 fatigue dynamic machine

Fatigue tests were performed according to ISO-1099 standard [12] under force-controlled conditions. Instron 1251 test machine, as shown in Figure 3, with a 100 kN capacity is used for this purpose and each test was carried out until complete failure of the specimen. The experimental matrix included 20 specimens each for the core and surface regions. Tests were conducted at a stress ratio  $R = 0$  and a frequency of 40 Hz was adopted. The first tests were started with a maximum stress level close to the experimentally observed monotonic yield strength, and for the next tested specimens, the stress range

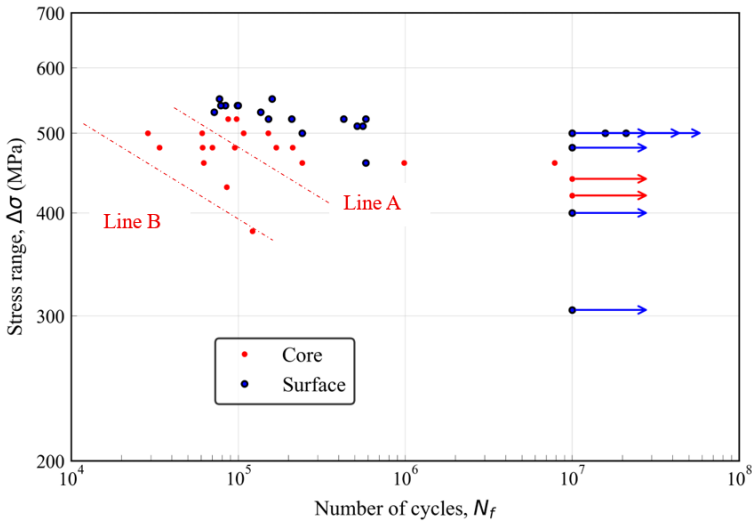
Figure 4. Fatigue data of core and surface specimens

The fatigue data of the tested specimens are presented in the Appendix. Tests with number of cycles without failure  $N \geq 10^7$  are considered as run-outs and are indicated in the subsequent figures by an arrow attached to the test result symbol. Figure 4 shows the fatigue data of specimens from the surface and the core regions. Clearly, the surface specimens show a higher fatigue resistance. The core specimens show a large scatter where it seems that the data can be divided into two subgroups that follow distinct linear curves, as shown in the figure. The data that follow line A show a fatigue resistance slightly lower than surface specimens. The core specimens that are in line with line B exhibit relatively very low fatigue resistance. This is due to the presence of a defect as will be shown in the subsequent section.

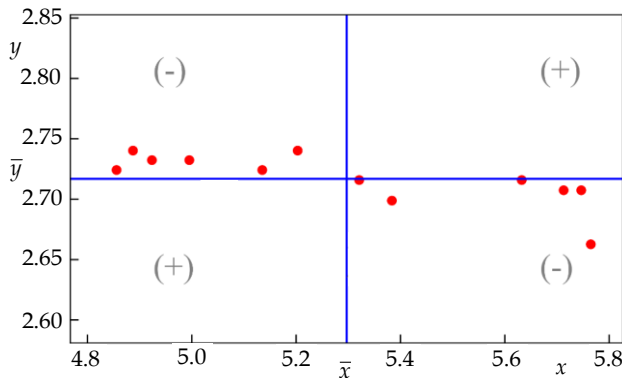
Figure 5. Graphical illustration of the correlation coefficient (Surface specimens)

Figure 5 illustrates the correlation coefficient for the surface specimens, the data show a negative relationship between the two variables which is expected in fatigue problems. Some of the data are quite close to the mean lines which indicate a low strength of the linear relationship between the variables. This can be confirmed by looking at the parameters  $\text{Corr}$ ,  $R^2$  and the  $P$ -value shown in Table 5. Cook's distance is a way to identify points that negatively affect the regression model. The measurement is a combination of each observation's leverage and residual values; the higher the leverage and residuals, the

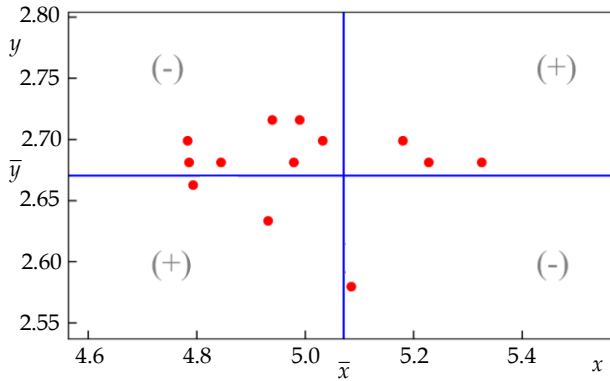
Figure 6. Graphical illustration of the correlation coefficient (Core specimens)

Figure 6 illustrates the correlation coefficient for the core specimens. Notably, 5 out of 13 data points lie in the positive quadrant, which is counterintuitive, as in fatigue  $\log(N)$  and  $\log(\Delta\sigma)$  are expected to have an inverse relationship, resulting in a negative slope. The calculated correlation coefficient is very low,  $Corr = -0.206$ , indicating a lack of correlation and suggesting that a linear relationship is not present. Consequently, performing linear regression analysis on this dataset would be inappropriate. While removing outliers is a

common method to refine data for analysis, nearly 40% of the points (5 out of 13) qualify as outliers, making this approach unfeasible. As a result, deriving a mean *S-N* curve for this dataset is not possible. The significant scatter in the data is attributed to the presence of defects in the core specimens, which are considerable in size compared to the cross-sectional area of these small-scale specimens. Note these specimens are not representative of a full thick plate, where the cross-sectional area is much larger, and the impact of such defects is less pronounced. When defects are as such significant, the fatigue crack propagation is more appropriate. Note, if small structural details are machined out of thick plates that contain similar defects, it is expected that the fatigue resistance will be considerably poor.

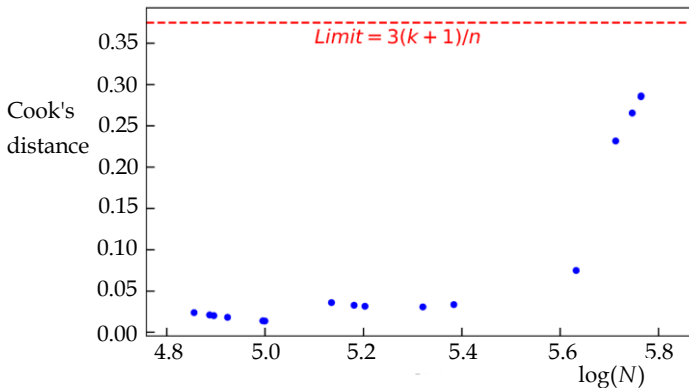
Figure 7. Cook's distance (surface specimens)

higher the Cook's distance. If the Cook's distance for a given point is higher than  $3(k+1)/n$ , so it is highly influential. The parameter  $k$  is the number of independent variables and  $n$  is the size of the sample. Figure 7 shows the Cook's distance test for surface specimens, where clearly there are no data points that are highly influential however some of them show a higher distance than the other which explains the relatively low  $R^2$  obtained.

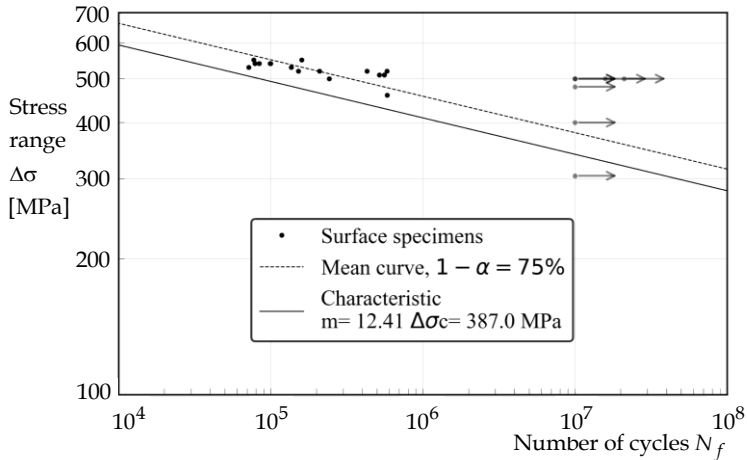
Figure 8. Characteristic design curve for surface specimens

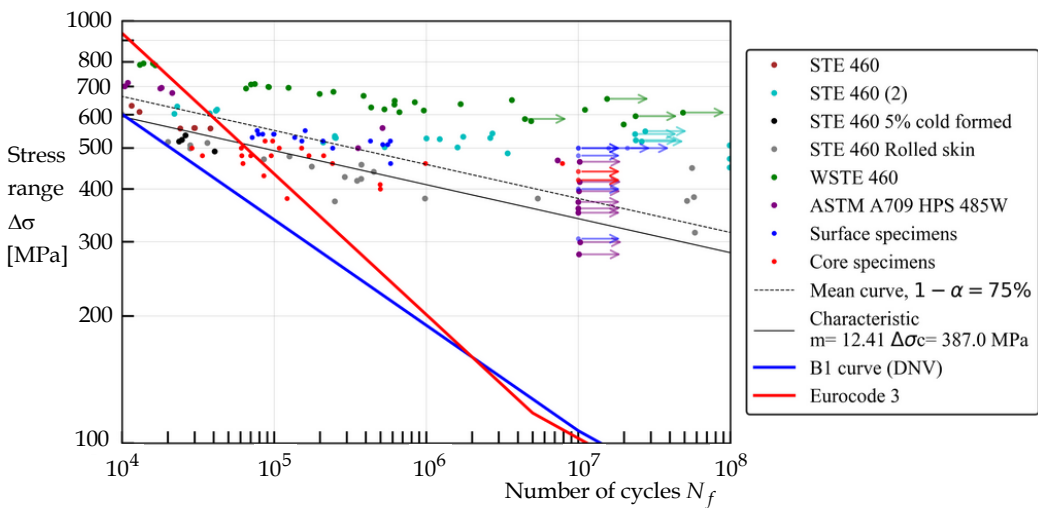
Figure 9. Comparison between the fatigue data of this study and fatigue data from the literature [19] as well as the Eurocode and DNV base material  $S-N$  curves

Figure 9 presents the fatigue data of this study together with some fatigue data collected from a the database made by Boller and Seeger [19]. The data include mainly STE 460 steel which is the German name for S460 and one North American steel grade equivalent to

S460 TMCP. WSTE is also and S460 made with TMCP and the remaining are either normalized or as received. Note the data was taken from test under reversed cycle loading  $R = -1$ , so the presented data was normalized to  $R = 0$  using the methodology prescribed in DNV-RP-C203. The data of surface specimens lay between the scatter of the fatigue data from the literature, while core specimens fatigue data show the lowest performance. The fatigue characteristic  $S-N$  curve proposed for surface specimen is not above the data with

rolled skin or that received cold forming. The Eurocode 3 base material design curve seems to be not conservative at high stress ranges whereas the DNV curve represent a lower limit for all the data.

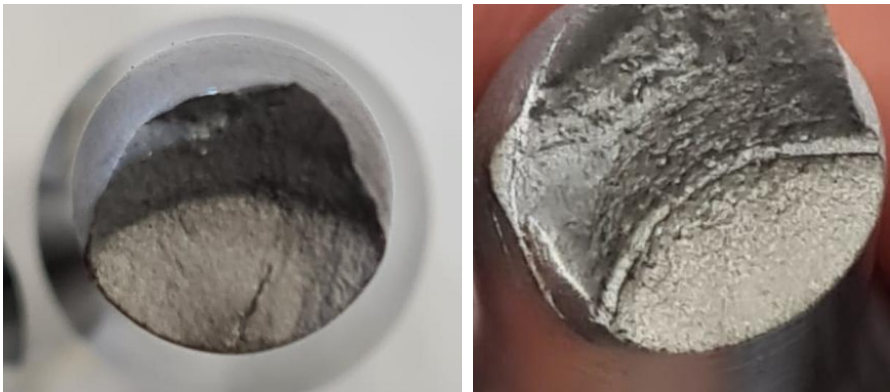
a) Core specimen failed due to large defect

b) Surface specimen failed without visible defect

Figure 10. Visual inspection of the fracture surface of a core specimen featuring a visible defect and surface specimen without a defect

An example of visual inspection is shown in Figure 10, where Figure 10 (a) shows the fracture surface of a core specimen "F-C-02-400-" that failed due to the presence of a large void which deserves lot of attention, and Figure 10 (b) illustrates a surface specimen with no visible defects. For both specimens, the crack seems to start from the surface or from a defect and propagate towards the centre until final fracture.

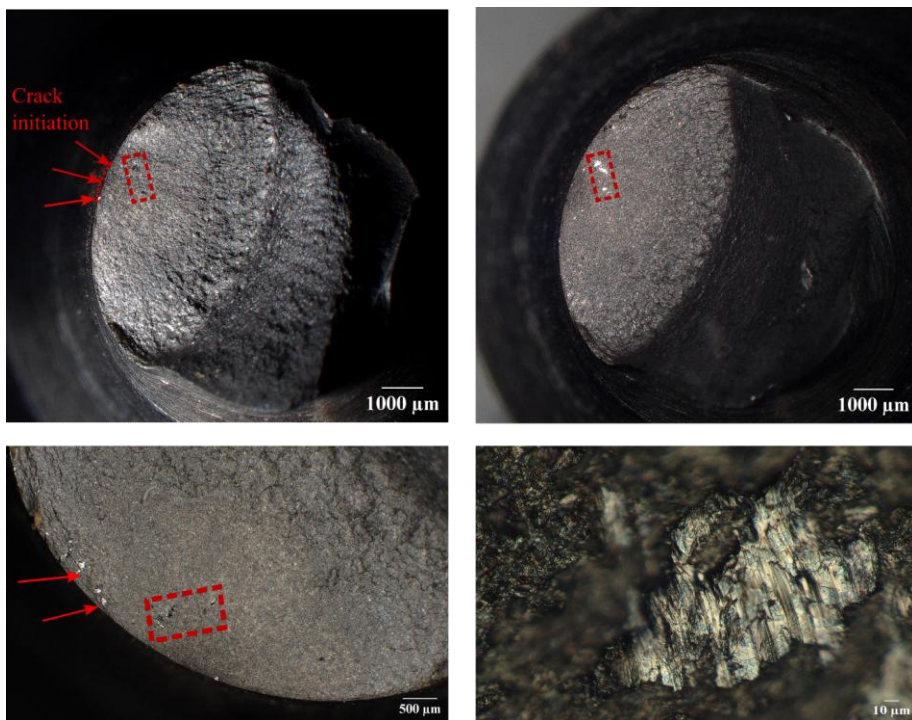
Figure 11. fracture surface of F-S-64-520-1

The Keyence VHX-X1 digital microscope was used for the light microscopy. Figure 11 shows the fracture surface of specimen "F-S-64-520-1," a representative surface specimen. River markings indicate the crack initiation site on the top left image. The top images

reveal a rough, flat surface typical of stage II stable fatigue crack propagation, as well as a teared region with large river markings typical of stage III rapid crack propagation and complete fracture. Reflective spots, highlighted in the red boxes near the surface, suggest areas of brittle failure, possibly indicative of intergranular decohesion near the surface of the specimen. The bottom right image shows a higher magnification of the shiny spots, where a grain seems to appear. Overall, the specimen exhibited a fatigue failure typical of ductile metals, the shiny spot did not penalise the fatigue life, as the specimen showed a long fatigue life before failure. Figure 8 shows the fracture surface of a core specimen (F-C-64-500-1) that features two bands of initial defects that appears as lamellar of voids. The authors believe that these are clusters of voids that appears in a lamellar form. The remaining fatigued surface is relatively small with some ratchet marks perpendicular to the void. Figure 13 shows the fracture surface of another core specimen (F-C-64-500-2) that features a relatively smaller defect of the same nature of the one observed in Figure 8. River marks show clearly that the crack initiated around the defect. Ratchet marks suggest

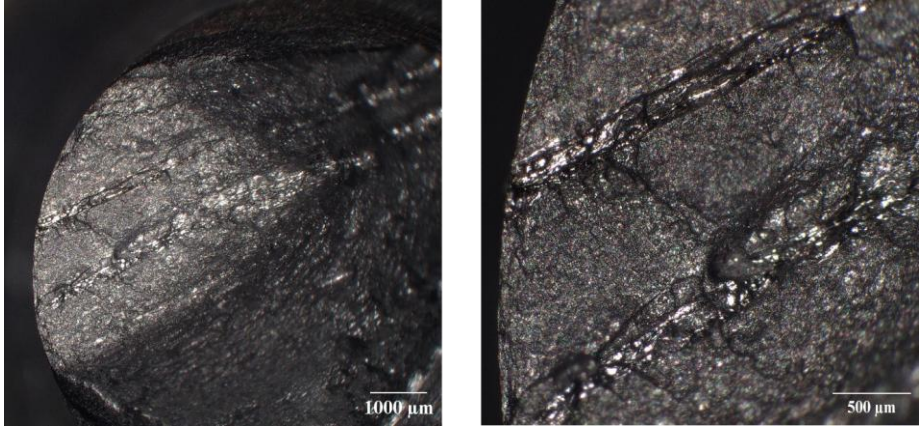
Figure 12. Fracture surface of F-C-64-500-1

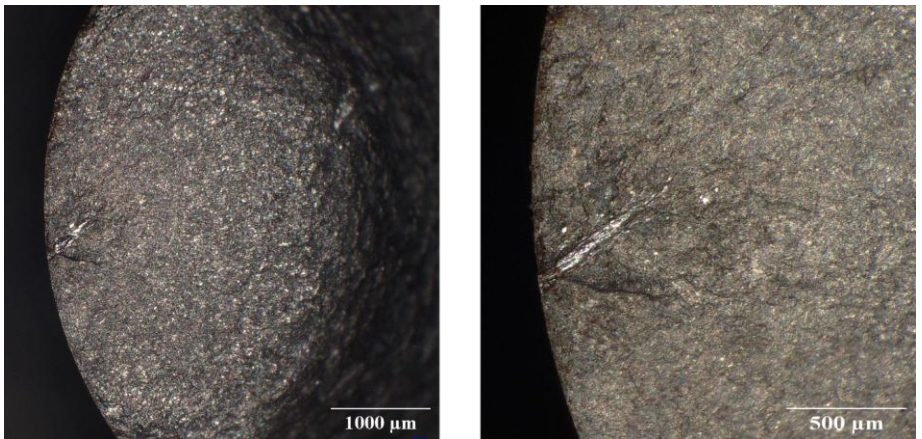
Figure 13. Fracture surface of F-C-64-500-2

that different crack initiation sites around the defect. The flat fracture surface typically of stage II crack propagation appears to be larger than the specimen in Figure 8, which confirms the longer fatigue life.

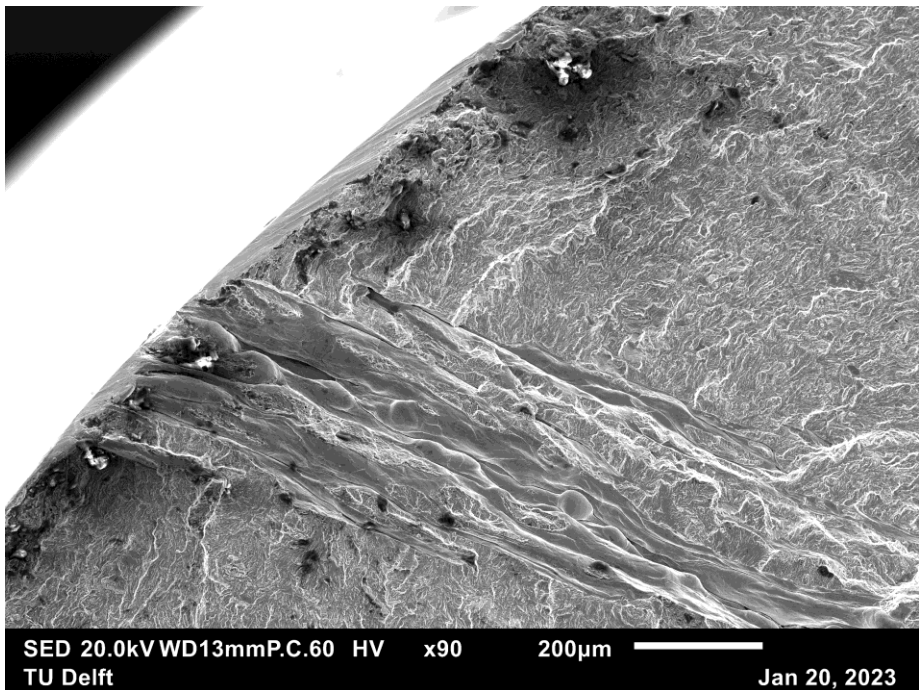
Figure 14. Electron microscopy of a crack initiation sites at a defect

The SEM was conducted on OL JXA 8900R microprobe using an electron beam with energy of 10 keV and beam current of 200 nA employing Wavelength Dispersive Spectrometry (WDS). From Figure 14, SEM micrograph with 90× magnification is shown for a specimen that failed from a large defect. The fatigue crack initiation process started around or within the defect. Looking at the area around the void next to the edge of the specimen, the surface morphology features elongated, wavy striations, micro-voids, and some dimples,

which could suggest ductile tearing or localized shear deformation. These features may be a result of material plasticity, influenced by stress concentration raised by the shape of the voids. At the void, the surface is smooth without any sign of striations due to fatigue loading, some grain boundaries are apparent. The river patterns suggest that the crack propagated towards the edge of the specimen and in radial direction towards the centre of the cross-sectional area. Generally, the fracture surfaces exhibited the typical mechanisms associated with the fatigue failure of metallic materials, such as the river patterns, traces of plastic deformation, and ductile dimples.
