Roof failures due to ponding – a symptom of underestimated development

J.N.J.A. Vambersky

Delft University of Technology and Corsmit Consulting Engineers, Rijswijk (ZH)

Key words: Light-weight flat roof, rainwater ponding, structural failures, structural safety

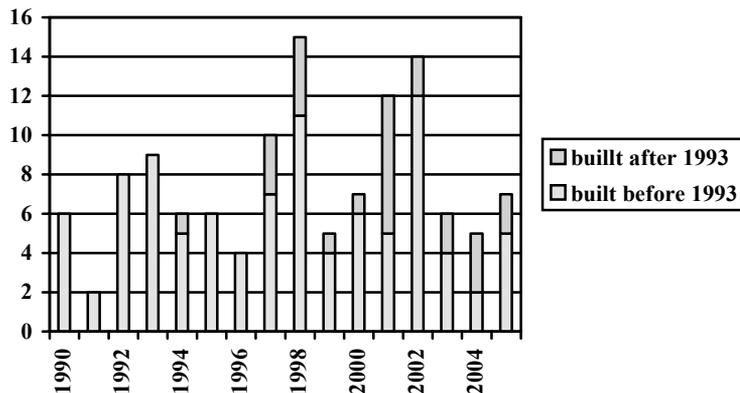
Figure 1: Number of light-weight flat roofs yearly collapsed in the Netherlands due to rainwater ponding. 50% of the total estimated. (Source: Hageman [1])

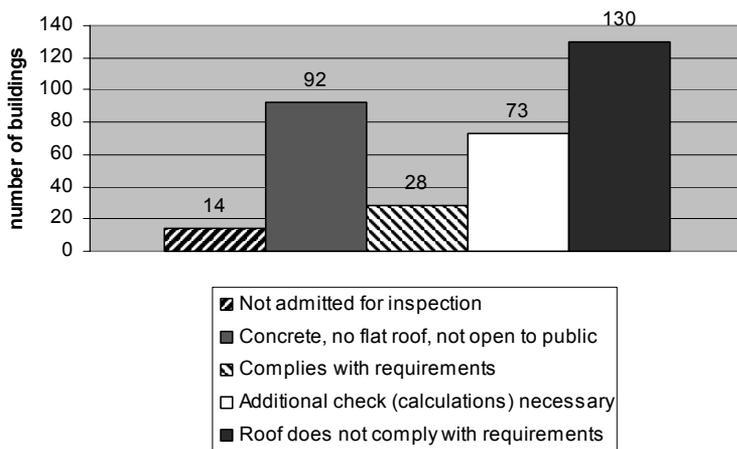
In this group objects were placed where it was obvious that the roof does not comply with the code requirements. In most cases the emergency rainwater overflows were missing. In case of blocked regular rainwater discharges, here an excessive rainwater accumulation was possible.

It has to be noted that for the roofs falling in category D, although these roofs do not comply with the code requirements, the danger of roof collapse due to rainwater ponding does not need to be imminent.

Figure 5: *Inspection results for objects with flat roofs*
(Inspections carried out in the period 2004 – 2006)

It is also clear, that for the roofs in category C and D, that do not comply with the code requirements, calculations have to be made to determine the measures that are necessary to take for improving these roofs. For such calculations, detailed data of the roof structure have to be available, such as steel sections used, steel grade used, etc. This is however not always the case, or is unproportionally difficult to obtain.

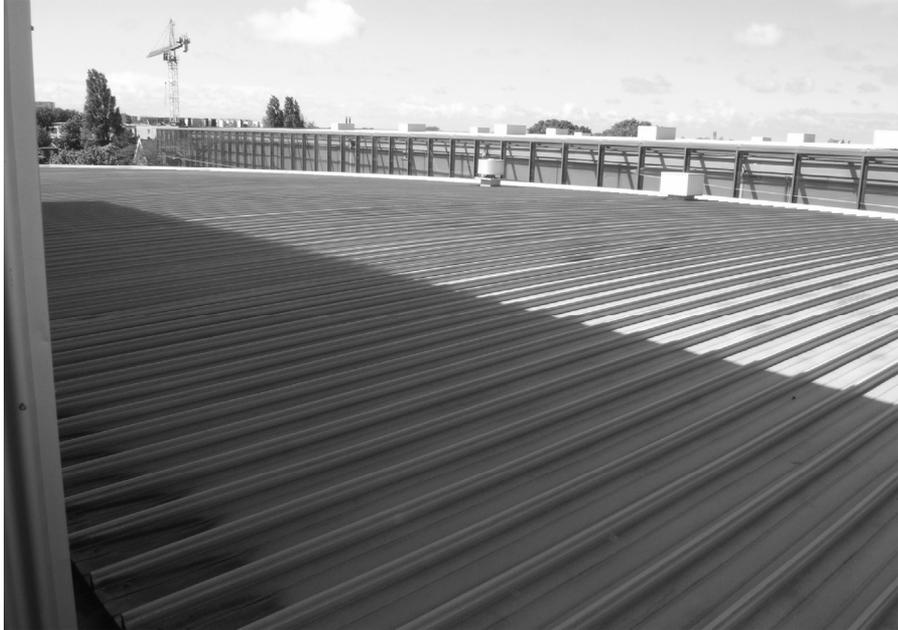
Objects in this group had in general roofs with sufficient slope, no or very low upstands, and / or such a detailing, that it was obvious that rainwater ponding was out of the question. (See for example Figure 6).

Figure 6: An example of light-weight flat roof where already the detailing only (elevated trough roof sheeting under sufficient slope in combination with lower positioned roof gutters) prevents any form of rainwater ponding that could impair the structural safety and quality of the roof
